From the Ground Up:

Albuquerque Apartments Realize Savings With Rebate and Retrofits

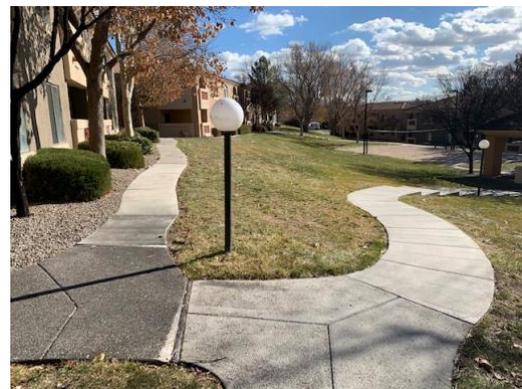
Sloping landscape made runoff an issue for the apartment complex.

Smart Use professionals certified by the WaterSense labeled Qualified Water Efficient Landscaper (QWEL) program conducted the landscape audit. It quickly became apparent that the best way to start was with La Paloma's outdated irrigation system and associated runoff issues that resulted from the land's steep slope.

- **Don't give up, even when things are going downhill.** The team faced challenges while updating the irrigation system for maximum water savings due to the sloping landscape. Green Summit monitored and adjusted irrigation system components until the system functioned as intended.
- **Spread the word.** La Paloma and ABCWUA prioritized communicating the importance of the water reduction efforts to apartment residents. As a result, residents responded positively to the upgrades and helped support the overall initiative.
